Test Intention:

In test 5006 we want to investigate the lifespan of our CFBUS.052 in a 100mm radius.

Name: M. Göllner Team: chainflex® Date: 28.05.2013

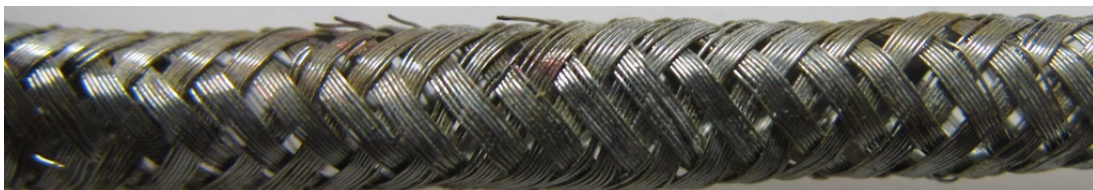
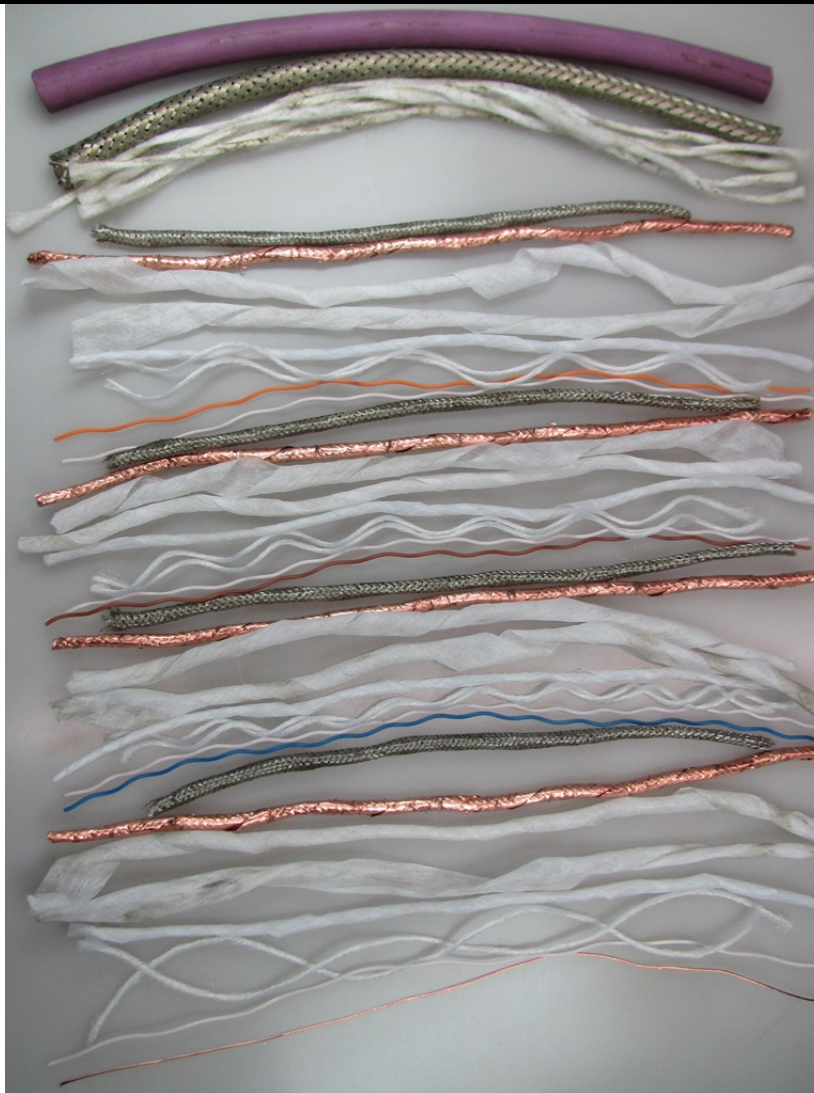
The condition of the cable no.1.1 (CFBUS.052) after 41.293.820 strokes

Strokes	41.293.820
Condition outer jacket	O.K.
Condition overall shielding	O.K.
Condition filler	O.K.
Condition centre element	O.K.
(2x0,15mm²)C	
Condition element shielding	Single broken wires
Condition element banding	O.K.
Condition filler	O.K.
Condition core insulation	O.K.
Condition conductor	O.K.
